# SEISMIC RISK EVALUATION

## ELIZABETH LOFTS CONDOMINIUMS 333 NW NINTH AVENUE PORTLAND, OREGON

MARCH 2015

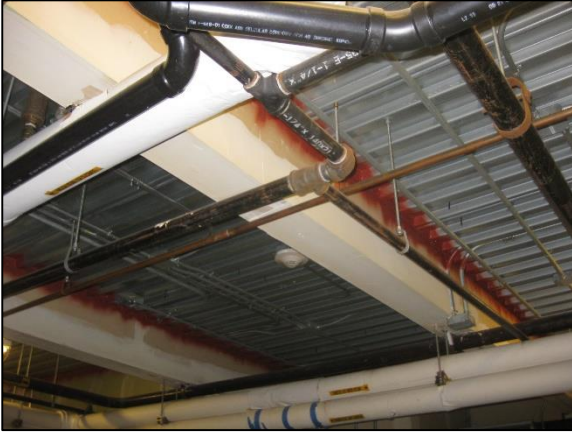
Photo A-5: Roof penthouse—natural gas piping

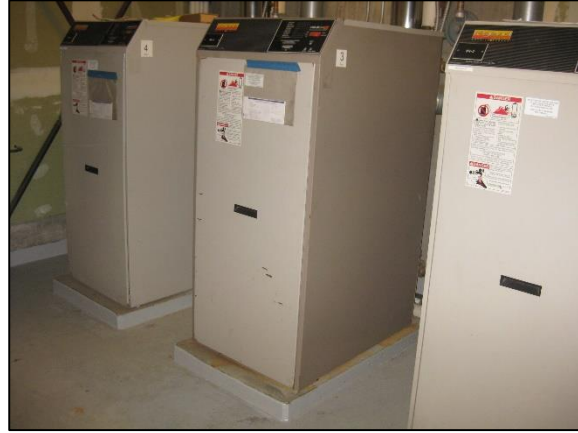
Photo A-6: Roof penthouse—boilers

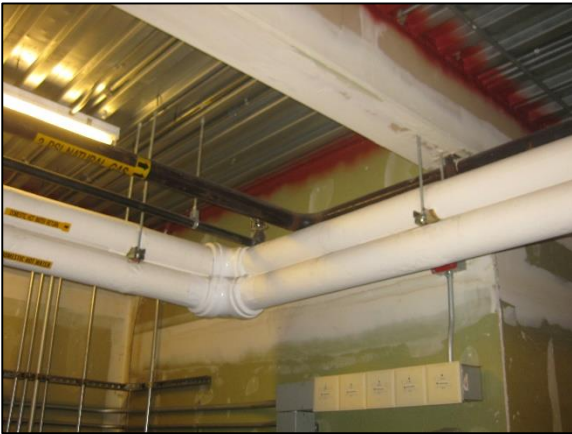
Photo A-7: Roof penthouse—suspended piping

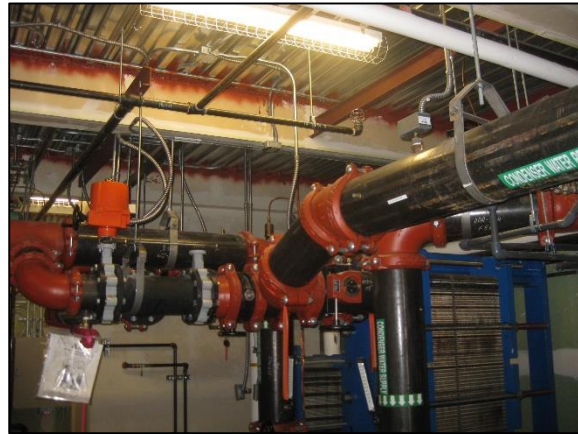
Photo A-8: Roof mechanical room—suspended piping

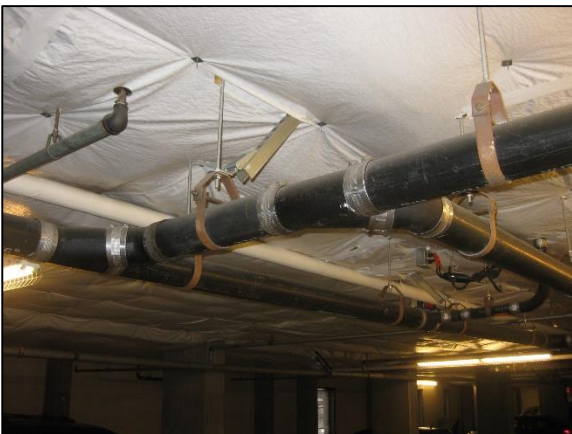
Photo A-9: Level 3—suspended drain piping

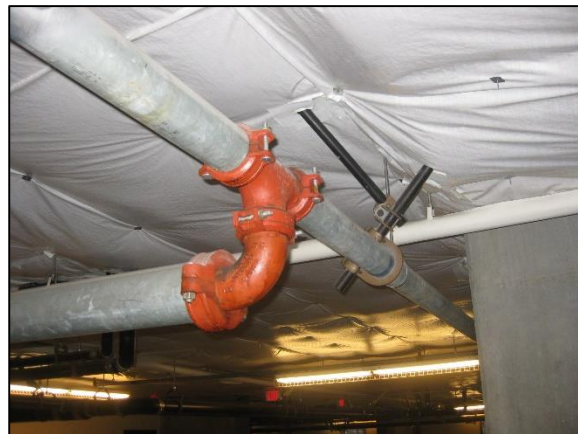
Photo A-10: Level 3—suspended sprinkler piping

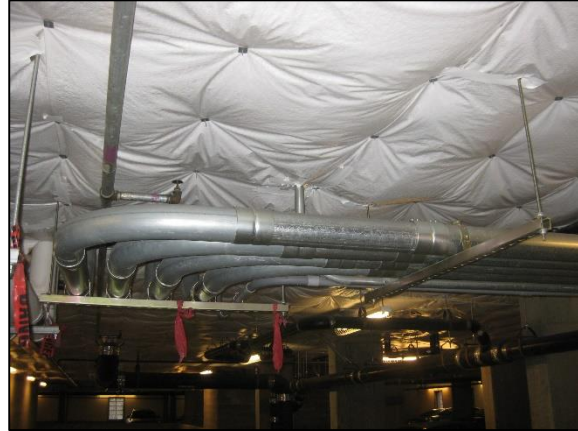
Photo A-12: Level 3—suspended conduits

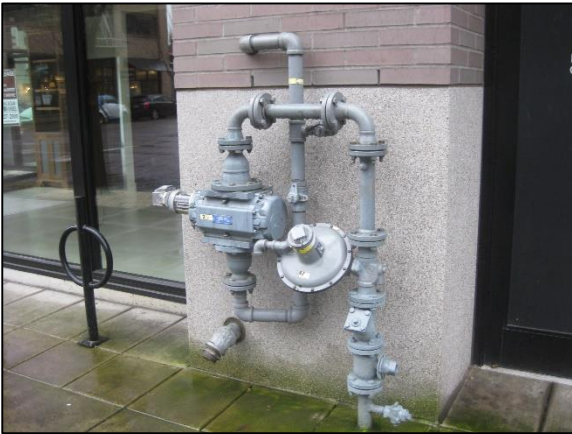
The building contains utility components and piping typical for this occupancy. The natural gas inlet did not include a seismically actuated shutoff valve at the time of the visit. Restraint of several equipment units appeared marginal. Seismic restraint of these components is recommended (see Appendix A).

Photo A-13: Natural gas main inlet
